OH-58 Pilot Display Unit (PDU) Simulated Crash Tests

December 1994

**United States Army Aeromedical Research Laboratory
Fort Rucker, Alabama 36362-0577**

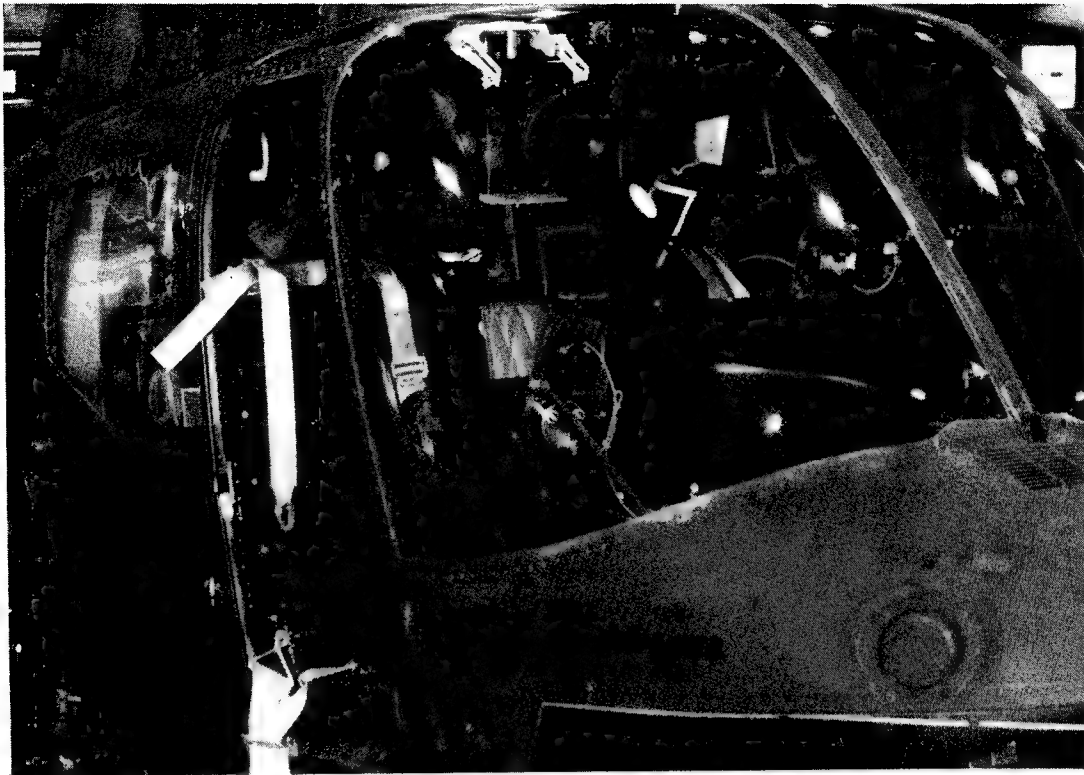
Figure 2. Front view of PDU installation, normal in-use position shown.

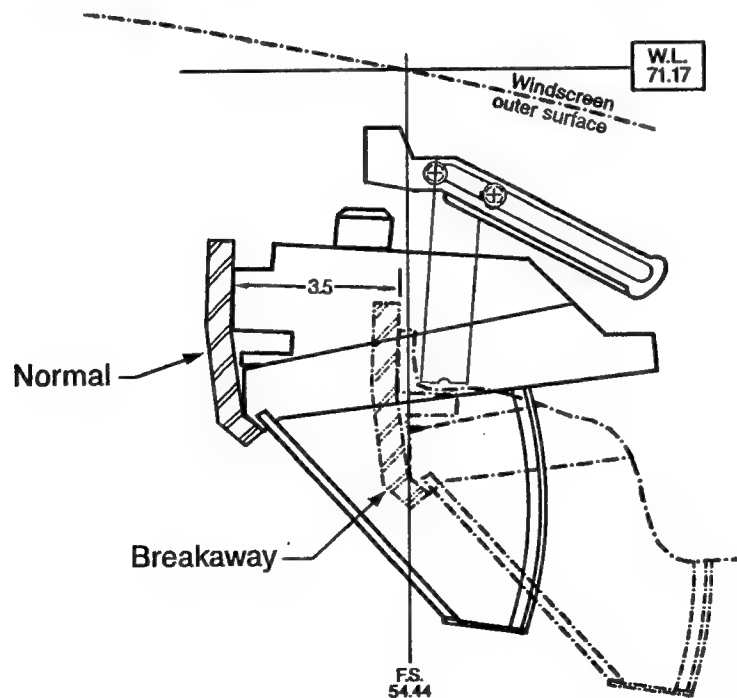
The unit as installed in the OH-58 helicopter is shown in Figures 1 and 2. The PDU is designed to break free at a deceleration of 2 G from the normal (flight) position, move forward and downward to the end of the slotted track, as shown in Figure 3. The prototype PDU was "drop" tested at the BHT facility in 1987 and the unit slid forward properly at 2 G deceleration (Powell, 1988). The PDU mount is detailed in BHT drawing 206-071-280-105.

Figure 3. Profile sketch of PDU location in OH-58 cockpit showing the normal and crash breakaway position.

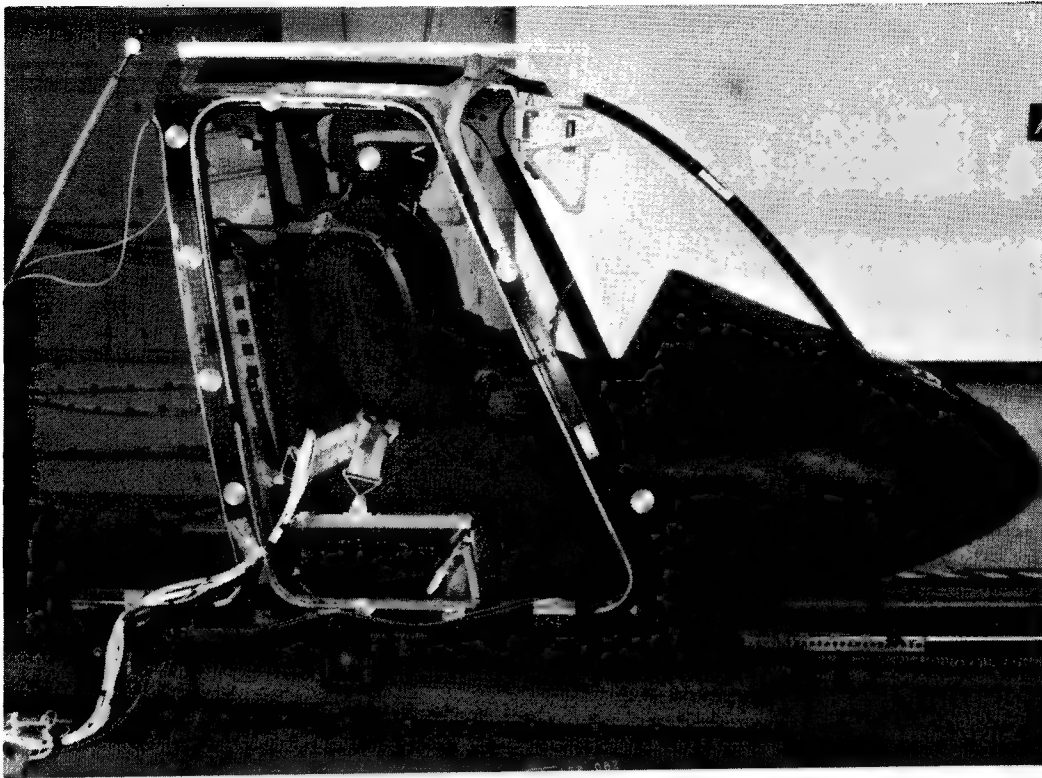
In this pure longitudinal x-axis test, the likelihood for PDU impact is greatest. The right dummy was placed 1.5 inches forward in the seat by use of a wooden spacer between the dummy and the seat cushion as shown in pretest Figures 12 and 13. Damage to the aircraft structure is documented in Figures 14 through 18.

Figure 12. Pretest of no. 88062; note potentiometer cable attached to back of helmet.

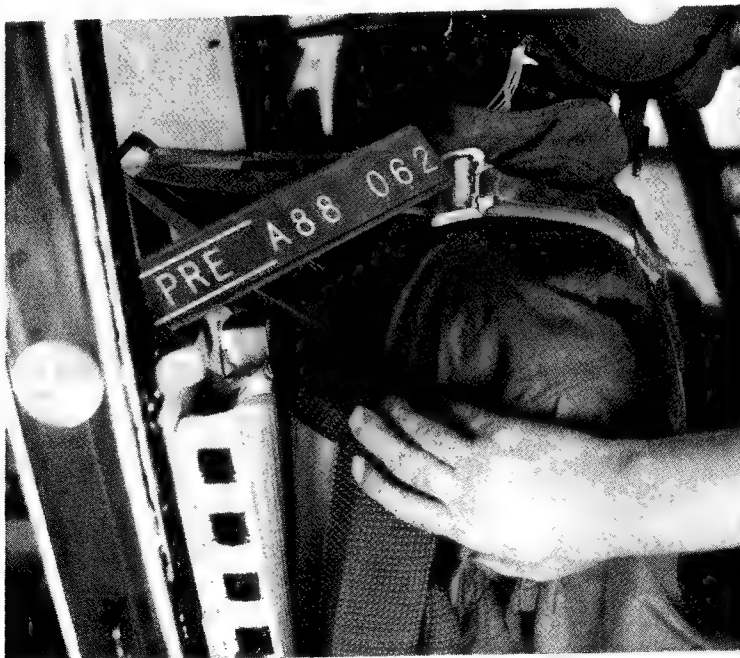
Figure 13. Pretest view of no. 88062; note board placed at back of seat to place right dummy 1.5-inch forward.

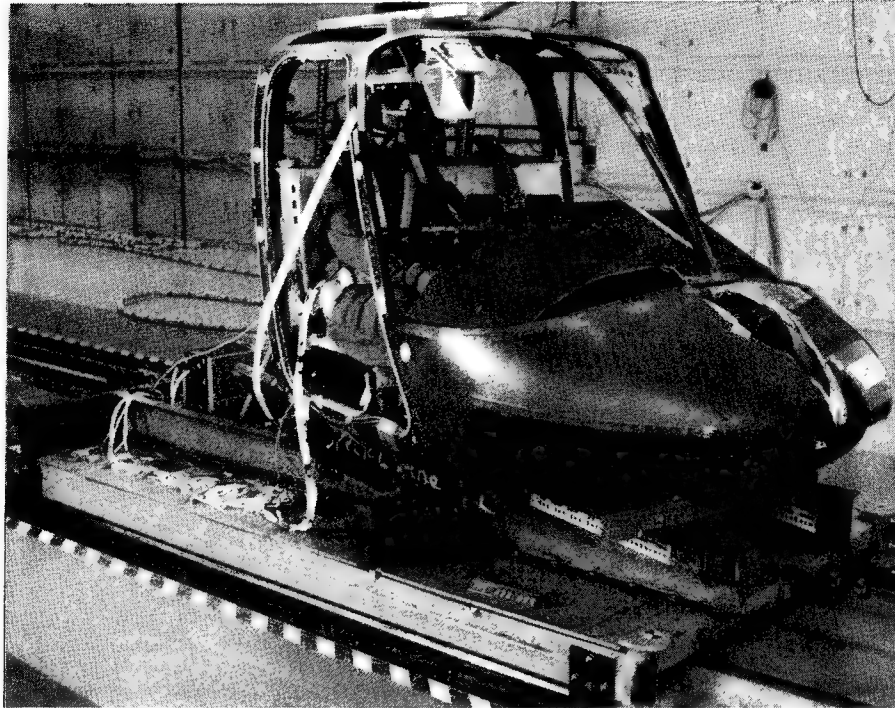
This test was a repeat of test 88063 except the dummy was moved forward 1.5 inch by placing a wooden block behind it and to the right by 1.5 inch by simply sliding the dummy to the right, flush against the lap belt inner surface (Figure 21). In addition, an 0.05 x 1.5-inch aluminum strap was added to the right door opening as shown in the same figure. This strap was intended to reduce elastic deflection of the upper door post.

Figure 21. Pretest view of no. 88064; note diagonal aluminum strap added to prevent forward movement of upper door post.

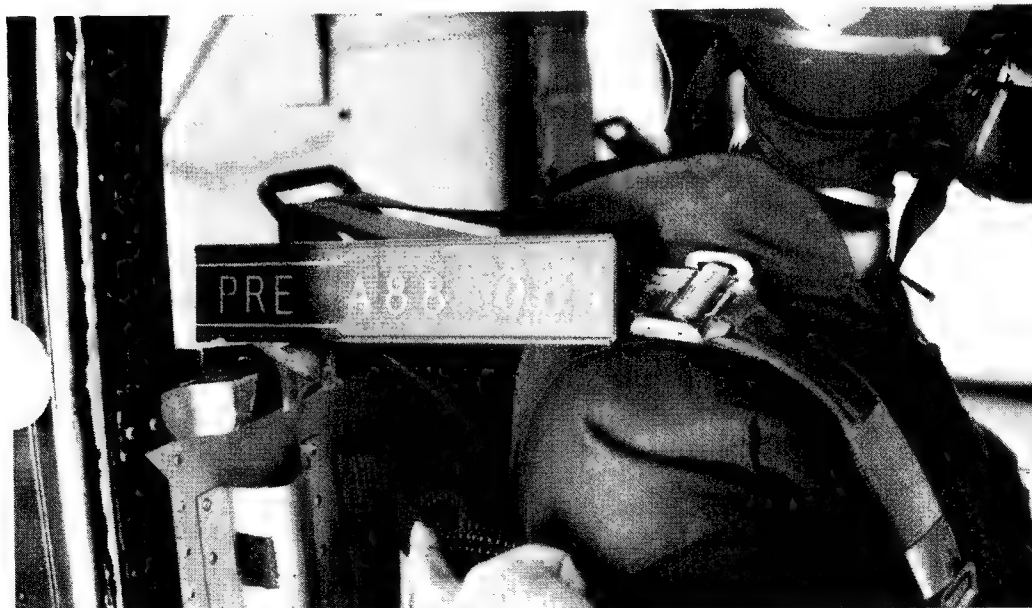
Figure 22. Pretest view of no. 88064; note board behind back cushion to move dummy forward 1.5 inch.

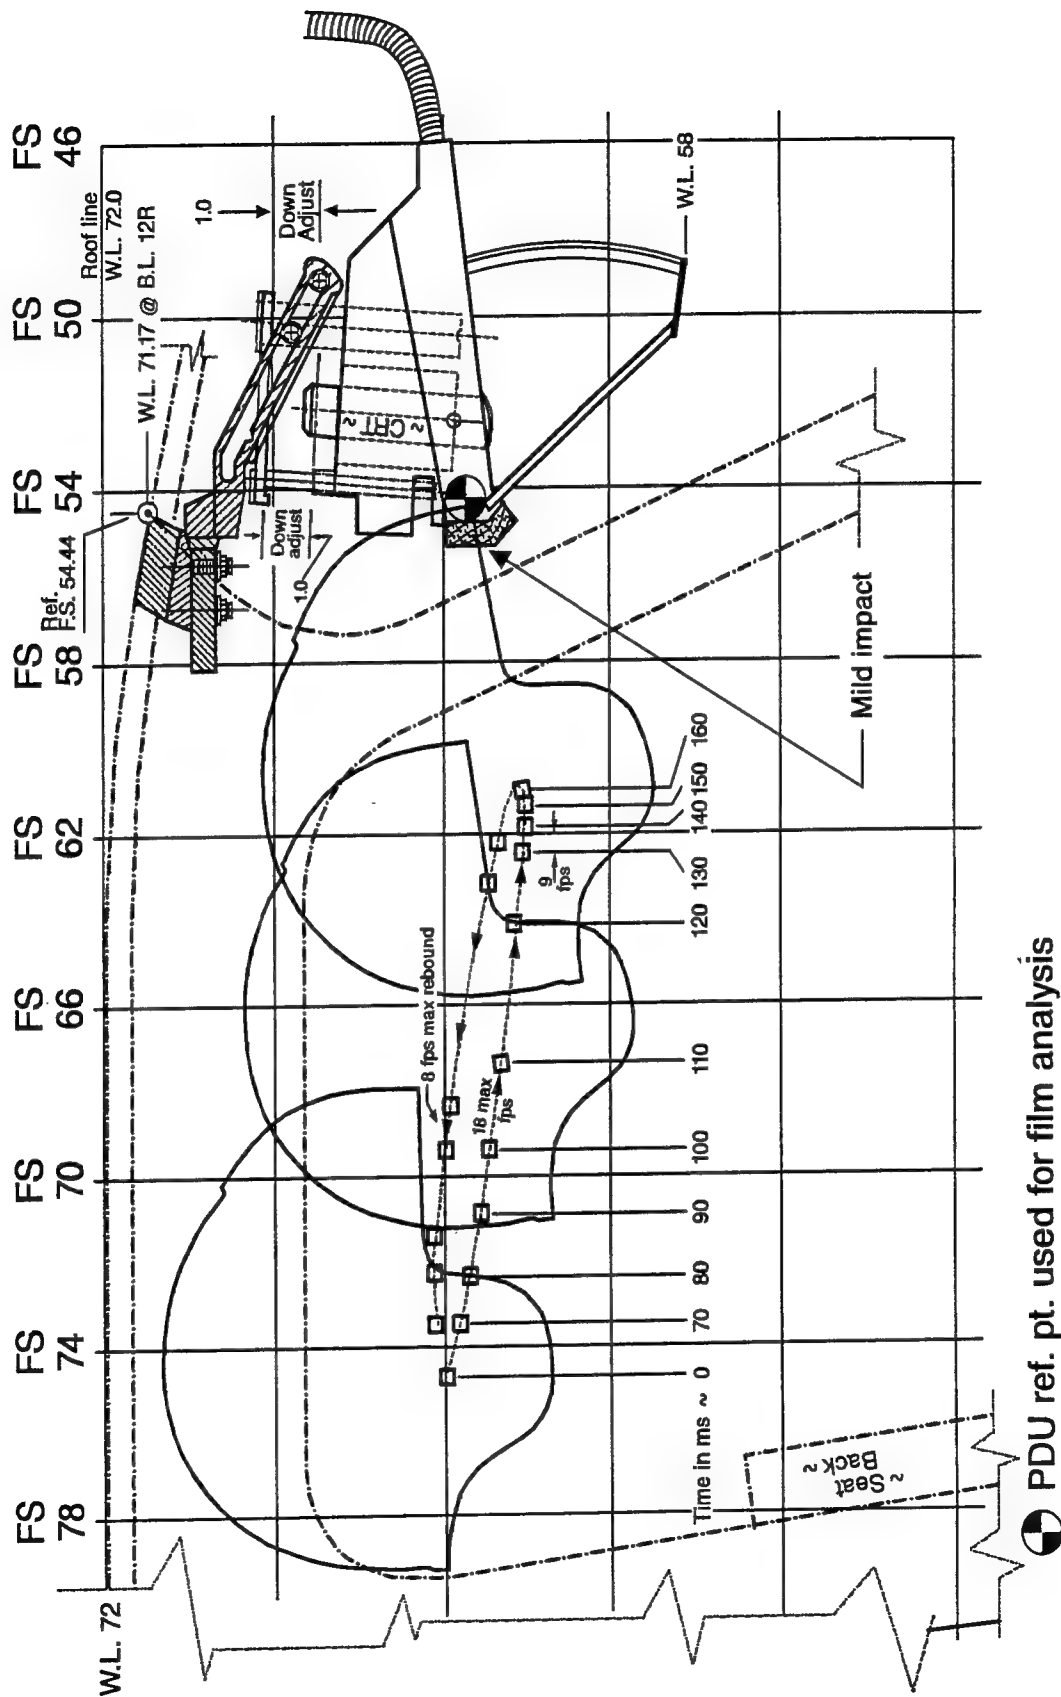
The movement of the right pilot's helmeted head was determined by film analysis and is shown to one-quarter scale for all five runs in Figures 27 through 31.

Figure 27. Helmeted head displacement in 30-degree pitch down test 88060.

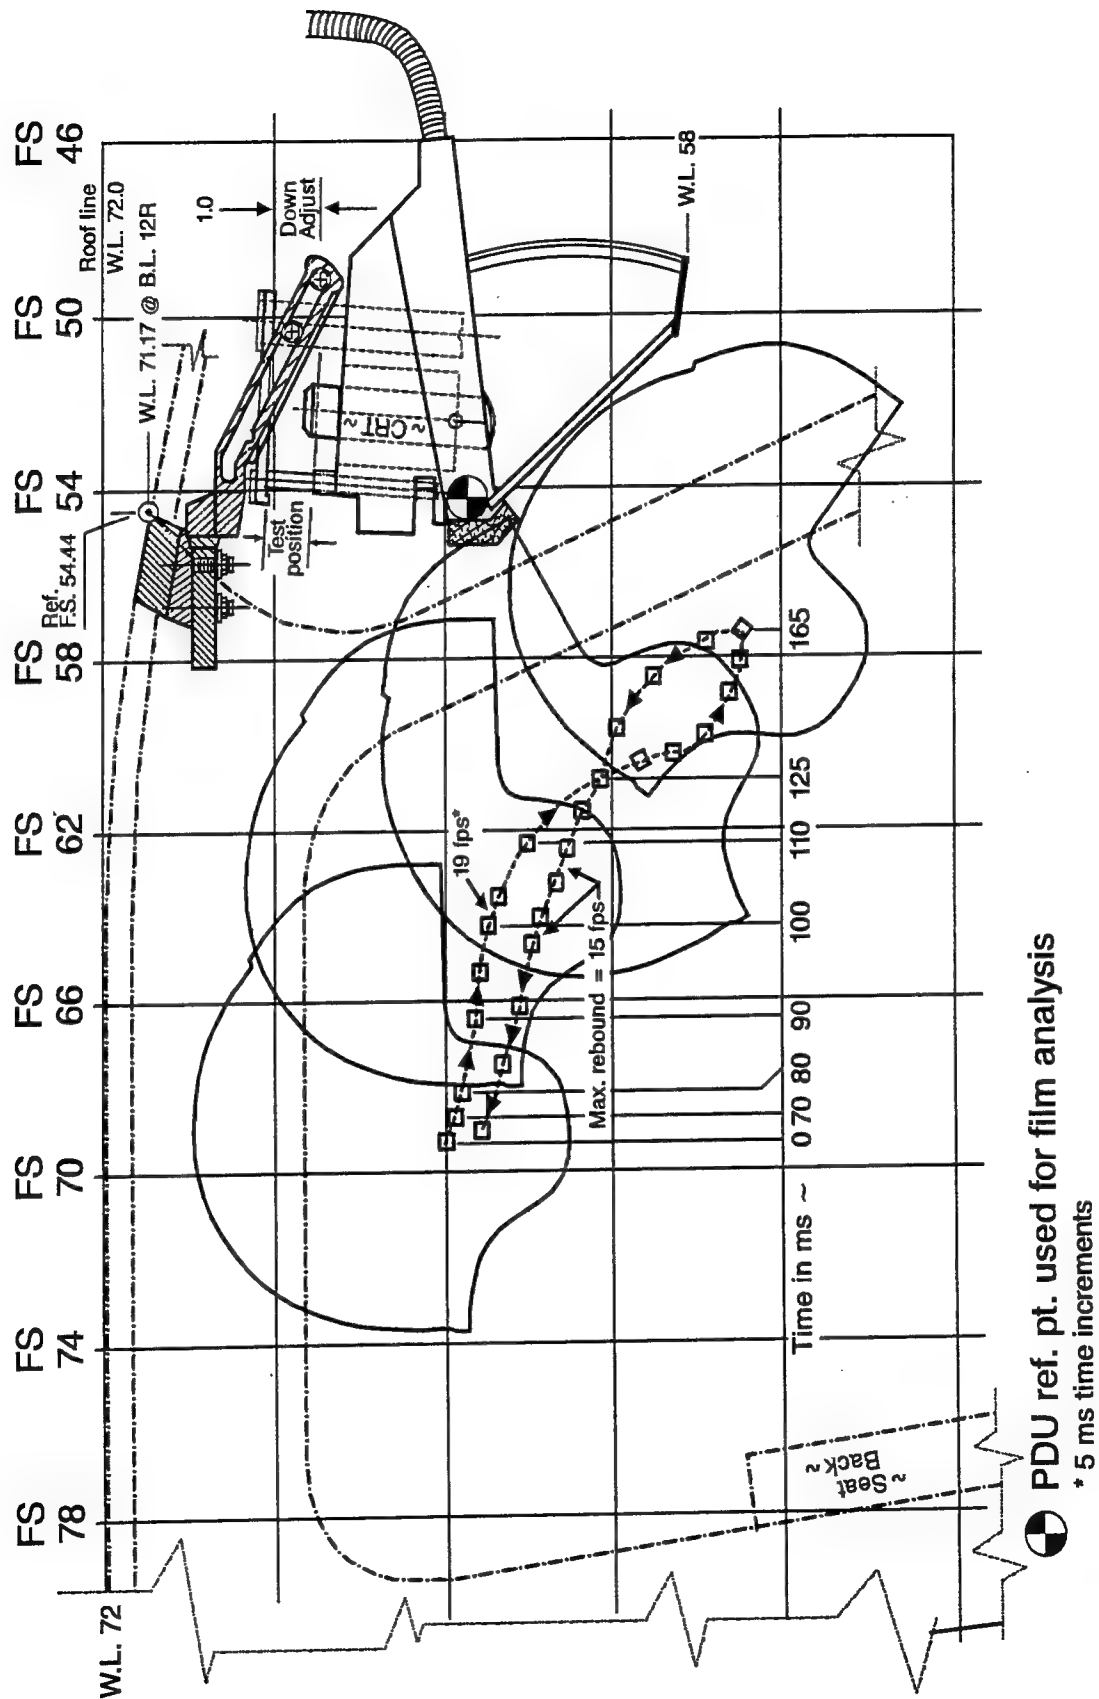
In spite of greater energy in this test over 88061, the right dummy's neck force and moment were little greater than the first test (88060), as shown in Table 3; the apparent anomaly is explained partially by the lack of a vertical impact vector in this test. However, reference to Figure 29 shows contact between the helmet and PDU at about 135 ms. Simultaneously, the movement in the neck about its lateral (y) axis also changes slope and becomes a constant level at just over 600 inch-pounds for the next 40 ms as seen in Figure A-2. In this time span between 135 and 175 ms, interpretation of Figure 29 shows the helmet's energy being reduced by: (1) foam compression, (2) inertial force against the PDU, (3) structural deformation of the PDU mount, and (4) sliding friction caused by 3 to 4 inches relative movement. Thus, it is highly probable the neck moment would have been much greater, perhaps twice as great if the helmet-PDU impact did not occur.

Figure 29. Helmeted head displacement in horizontal (x-axis) test 88062.
